SONAR DOME COATINGS
DEVELOPED UNDER NAVY CONTRACT
WITH NEW YORK UNIVERSITY >

Lab. Project 930-59, Technical Memorandum 2 SF 101-03-17, Task 8213

2 9 MAR 1968

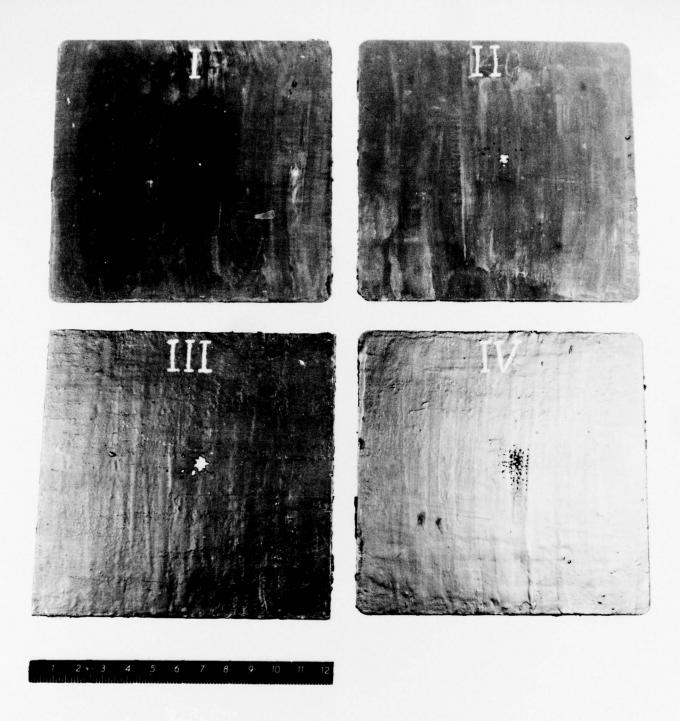
PHOTO 21495

- 6. The results of tests on the four coating systems are tabulated in Table 1, enclosure (2), with the resulting erosion patterns shown in enclosure (3).

- 7. The results of tests indicate that the experimental coating system applied to Panel I and submitted by New York University, is the most promising of the latest four coating systems submitted. However, although this coating system is an improvement over the three systems previously reported in reference (f), complete erosion down to the metal base still occurs, and the coating is, therefore, not considered suitable for use on sonar domes.

Eroded Are Topcoat Paint Removed	Paint Removed To Bare Metal	R em arks
0.020	0.006	
0.027	0.009	After 23 hours, erosion of outercoats in 3 small areas in approx. center of panel. Eroded to metal base in one of these areas.
0.097	0.025	
0.188	0.079	After 23 hours, substantial scattered erosion of outercoats. Severe erosion to metal base in 3 areas.
0.231	0.152	
0.333	0.205	After 23 hours, substantial erosion of outercoats. Severe erosion to metal base in 3 areas.
0.080	0.071	
0.110	0.088	After 23 hours, severe erosion to metal base in 12 scattered areas.

ENCLOSURE 3 - VIEW SHOWING DEGREE OF EROSION OF N.Y.U. EXPERIMENTAL SONAR DOME COATING SYSTEMS

- 8. In discussing the results of tests with Prof. Kronstein of New York University, he has advised the Laboratory that further improvement will be made of the Panel I formulation. In this respect, Prof. Kronstein's attention was further directed to the possible reduction of the high film thickness (26.0 mils) of coating on Panel I.

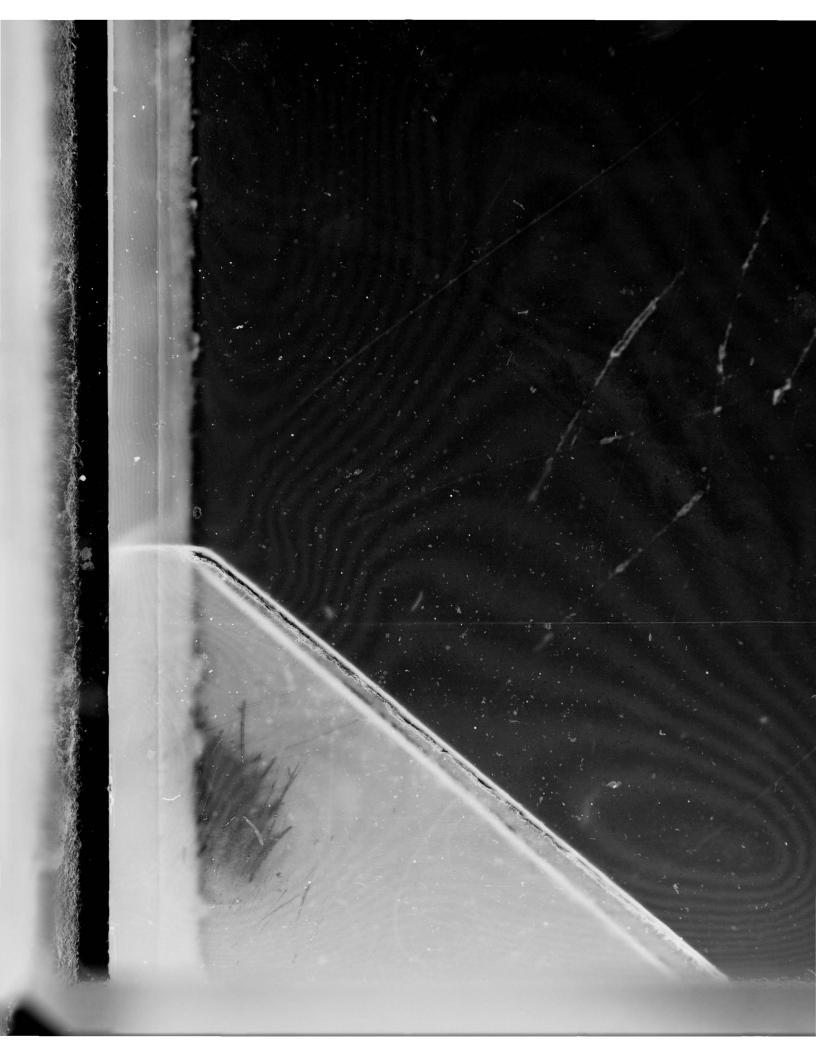
- (3) Photo 21495, View Showing Degree of Erosion of Experimental Sonar Dome Coatings
- 1. The U.S. Naval Applied Science Laboratory is monitoring the reference (a) contract with New York University, currently funded by NAVSEC under Sub-project SF013-13-01, Task Sub-project SF013-13-01, Task 12415, for the development of sonar dome coating systems which have good erosion resistance, good antifouling properties, and are able to remain adhered when exposed to high level sonic pulses generated by high power sonar transducers.
